Manhole Inspection Summary

Manhole # S29II_034MH

Location Address: **1714 LAURENS ST**

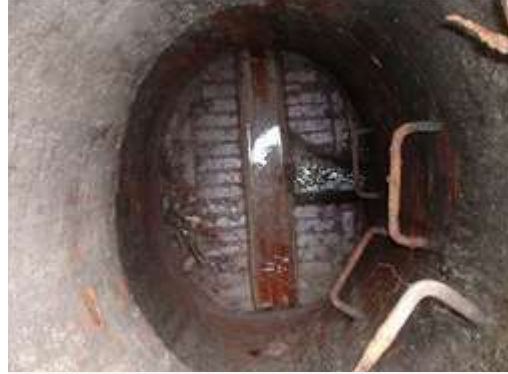
Top View

Corroded and missing steps. Bench debris.

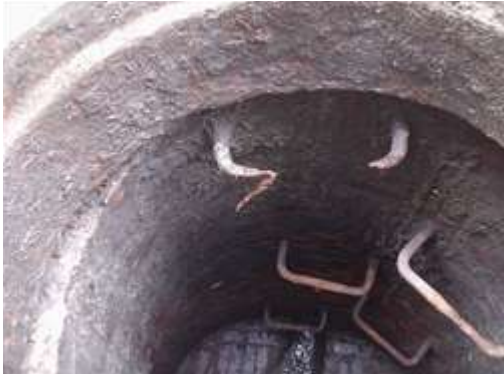
Defect

Frame leaks. Adjustment deterioration and infiltration. Corbel infiltration - other side.

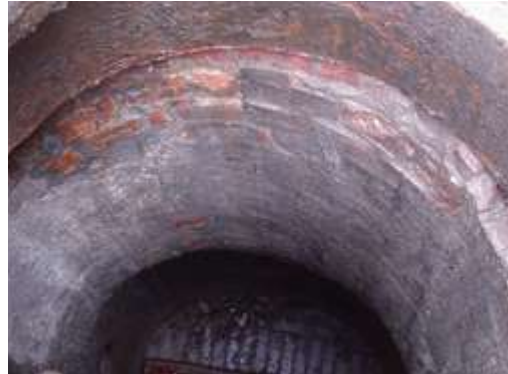
Defect

Frame leaks. Adjustment deterioration and infiltration. Corbel infiltration.

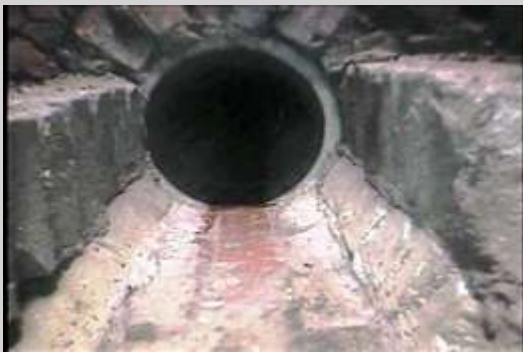
8 in. Circular Gravity Sewer Pipe Out @ 12 O'Clock

Infiltration: **Evidence** Pipe Seal Cond: **Unknown**

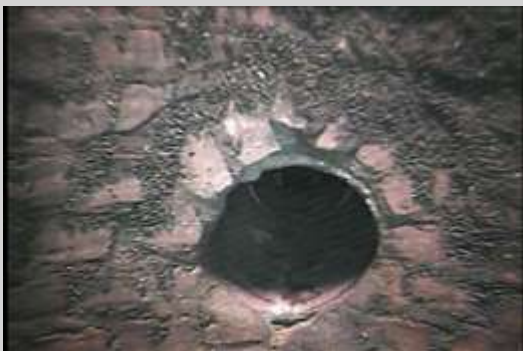
8 in. Circular Gravity Sewer Pipe In @ 6 O'Clock

Infiltration: **Evidence** Pipe Seal Cond: **Unknown**

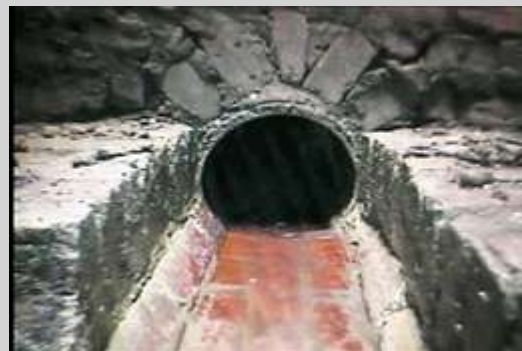
Drop In @ 6 O'Clock

Barrel deterioration and infiltration. Channel deterioration.
